FIRE & EMS MESSAGE

LIGHTNING PROTECTION FOR STATIONS

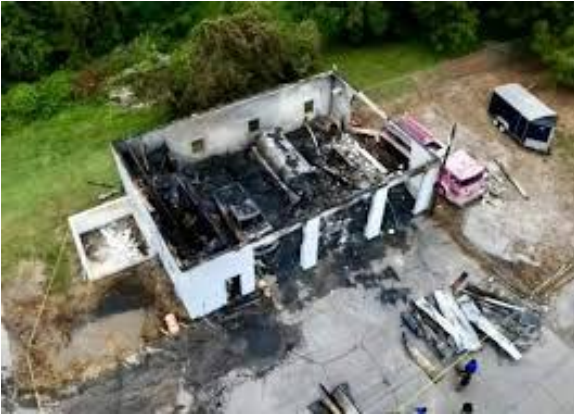
“A fire, possibly caused by a lightning strike, destroyed the station and three rigs, including the department's pride and joy – a 1941 engine”, Vine Grove (KY) Fire Department Chief Matt Haddle told a local television station.

Let This Be a Wake-Up Call to Check the Integrity of Our Lightning Protection Systems!
